Technical Abstract

This investigation focuses on the quantification of strength increase due to repair and the durability of repairs in a harsh water environment, both areas in which there is little academic knowledge. The aim was to provide confidence in repair performance, giving scientific backing to industry practices.

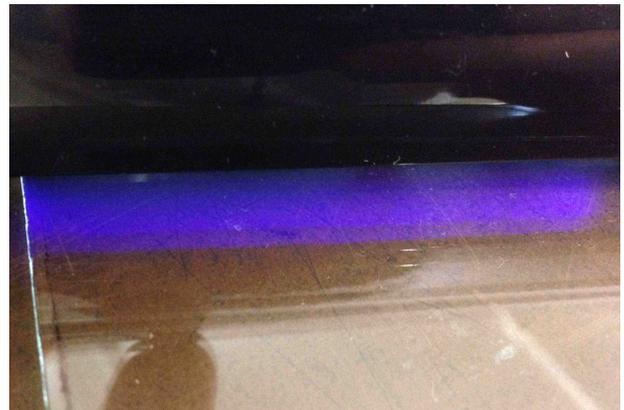
Figure 6: Non tin side

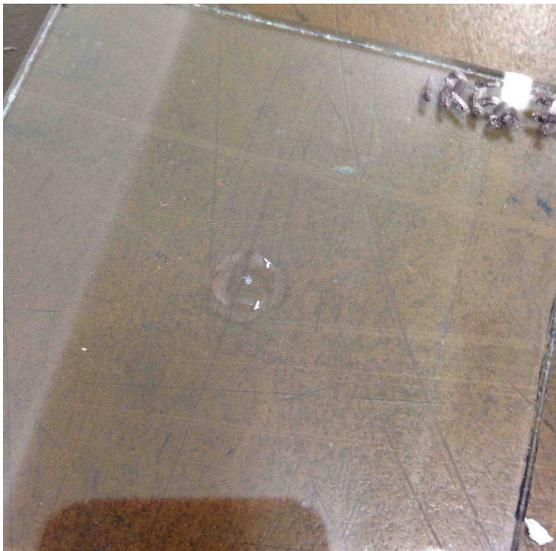
Figure 15: Resin is applied to the flaw.

The repair process is depicted from Figure 15 to Figure 19.

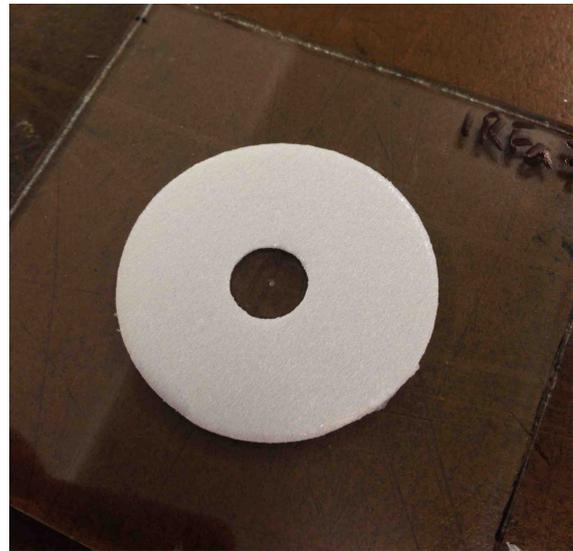
Figure 16: Adhesive foam is applied around the flaw.

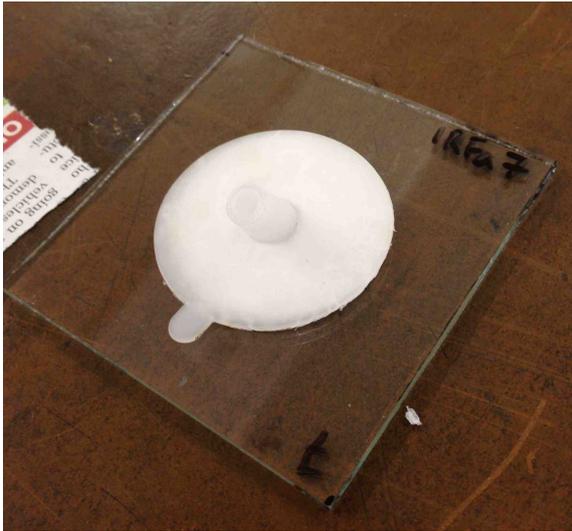
Figure 17: A plastic covering is applied over the foam.

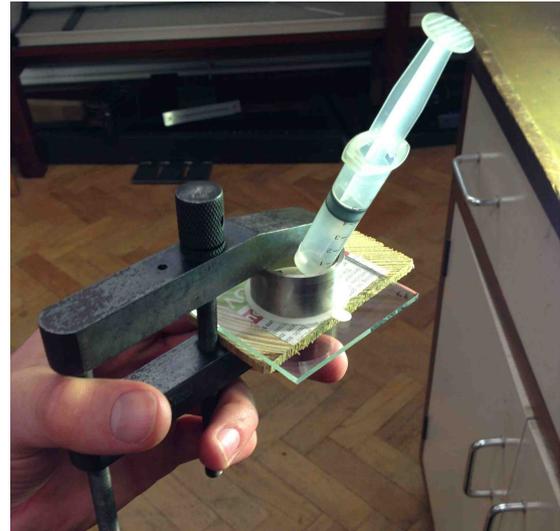
Figure 18: A clamp is applied over the plastic cover and a syringe is used to apply pressure to the resin in the flaw.

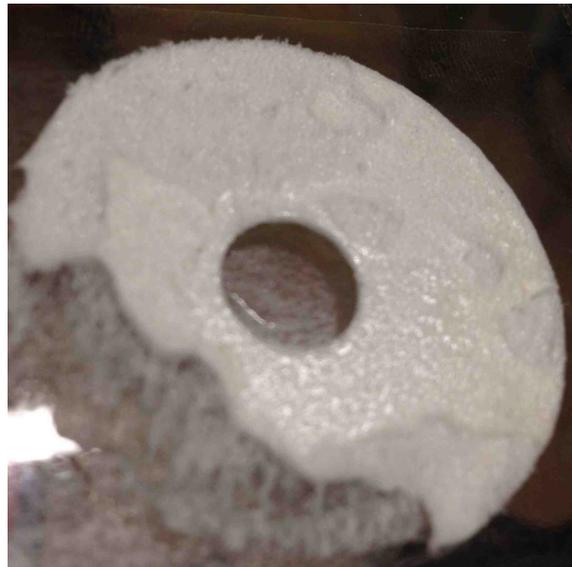
Figure 19: The covering is peeled off, leaving the resin in the flaw

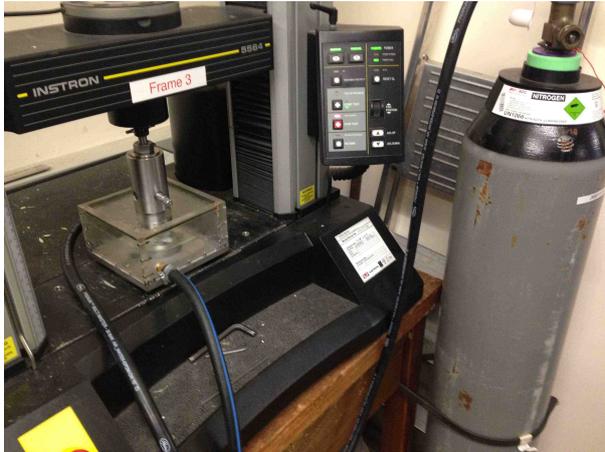
Figure 21: Inert testing set up

inlet and an exhaust on opposite sides to accommodate the nitrogen piping. The set up is shown in Figure 21 and Figure 22.

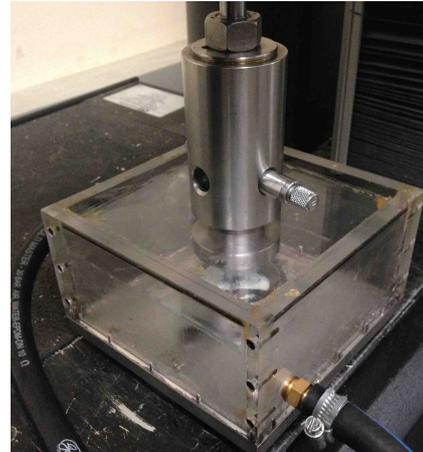
Figure 22: Nitrogen chamber

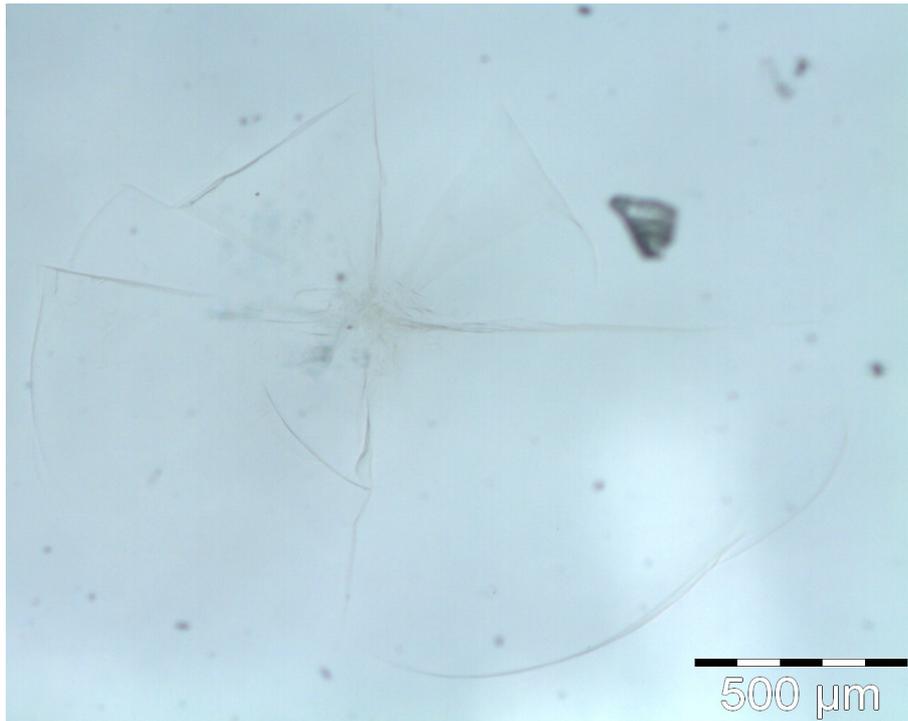
Figure 24: Resin shown penetrating into an indentation.

The flaws are barely visible showing that the resin has indeed penetrated into the flaws. The weathered glass shown in Figure 25 is the same specimen as shown in Figure 9. The black marks are dust and dirt, which have caught on the surface of the resin after having been stored in the lab for a week.

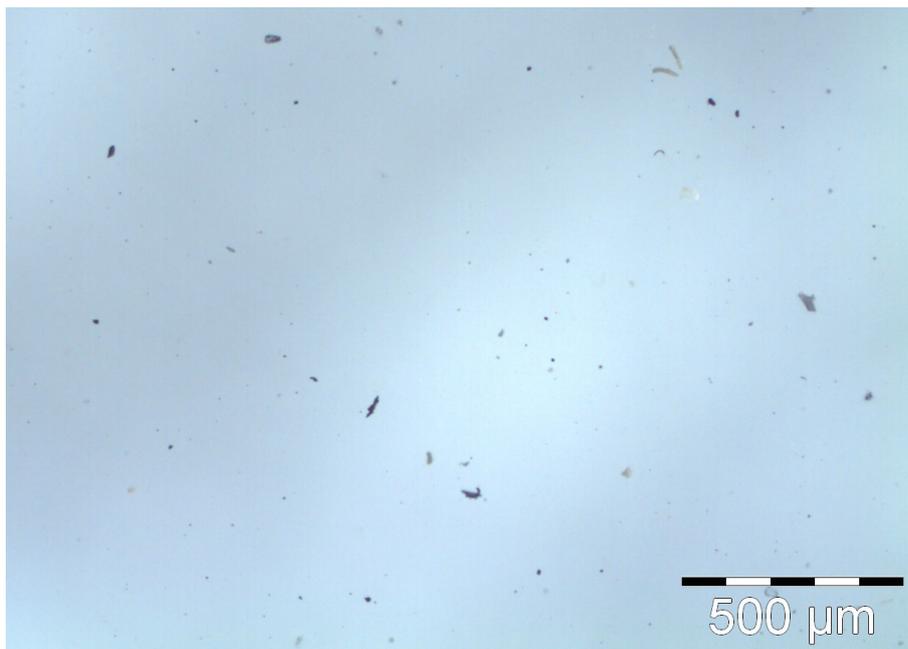
Figure 25: Resin on the naturally weathered surface – flaws are no longer seen.
