Author's Copy: Conference Paper published in Proceedings of Glass Performance Days Conference, June 2017, Tampere, Finland.

Influence of Aging on Post-Fracture Performance

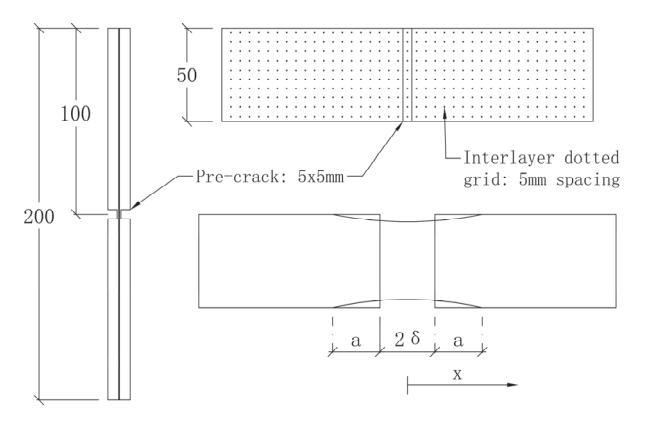
Through crack tensile (TCT) tests were conducted on 200 mm x 50 mm laminated glass specimens as shown in figure 1. The specimens were manufactured from two layers of 6 mm annealed soda-lime-silica glass, laminated with a 0.76mm Saflex RB41 PVB interlayer. A dotted grid was printed on one side of the interlayer. The lamination process was representative of standard production techniques.

Figure 1 Test Specimens

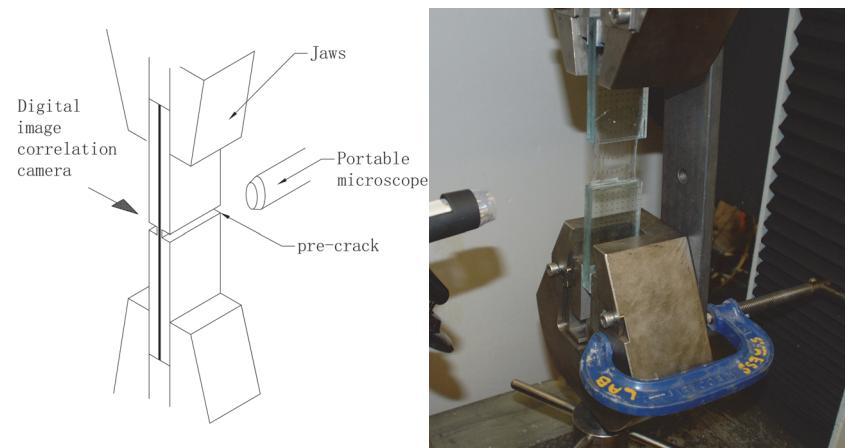
The TCT test was initially developed by Sha et. al. [12], and has since been used widely as a simple and controlled method of assessing post-fracture performance. The test set-up is shown in figure 2: the glass is clamped rigidly in an Instron 5500R universal testing machine. A tensile force is applied to the 2-ply laminate which has a single, coincident fracture in each glass ply. The applied load is transferred across the glass fracture by the polymer interlayer which elongates, and delaminates from the glass surfaces. The specimens fail by tearing of the interlayer or by excessive delamination between the glass and the interlayer. A *pre-crack* was created by grinding a 5 mm wide and \approx 5 mm deep channel across the mid- line of each glass ply using a diamond coated wheel as shown in figure 1. This process left 1mm of glass intact on either side of the polymer interlayer. The pre-crack was formed after the weathering procedure, in order to ensure that the test was a true representation of weathering occurring before glass fracture.

Figure 2 a) Schematic of test rig, and b) image taken during testing.

Slip at the interface between glass and test rig was eliminated by bonding pure aluminium plates on the glass in the region to be clamped.

Whilst the test specimens were placed a small, but constant tension was applied. This prevented compressive forces causing buckling of the slender 'pre-crack'. Once secured the remaining 1 mm of glass was fractured in tension, immediately prior to testing. This significantly reduced the occurrence of damage to the interlayer. A displacement rate of $2\delta = 0.264$ mm/s was applied across the fracture such that the interlayer stretched and delaminated. This speed corresponds to that used during a previous study at the University of Cambridge. Applied force was recorded by the universal testing machine. Distortion of the dotted grid was captured using a high-definition video camera at 25 frames/second. The images were analysed using the open source digital

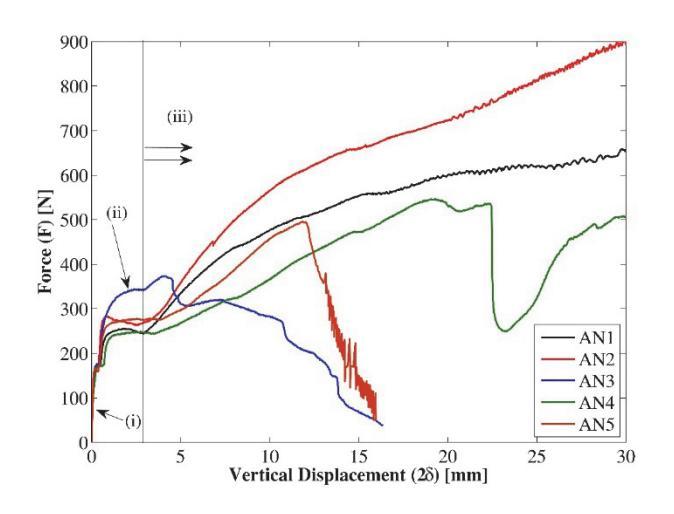
The response of the newly manufactured specimens is shown in figure 3. It can be divided into three distinct phases:

- Linear phase, with forces increasing to an average peak of 275 N. This phase is labelled as (i) in figure 3. The response is interrupted by a discontinuity at 160 N caused by movement in the test rig. During this phase the length of initially un-bonded interlayer stretches; little to no delamination occurs
- Steady-state phase during which delamination commences and continues at a roughly constant rate. The force also remains constant. This phase, labelled as (ii) in figure 3, continues until approximately 3 mm total displacement
- (iii) Failure phase beyond displacements of $2\delta = 3$ mm the response varies between specimens. This has been noted previously by Ferretti [14].

Figure 3 Force displacement response of the newly manufactured specimens.

Three different failure methods were observed: specimens 2 and 4 failed in tension across the delaminated interlayer; specimens 1 and 5 failed by slip between glass and jaws, both specimens exhibited large interlayer deformation prior to failure. Specimen 3 failed by interlayer tearing. This tearing occurred early in the test before significant delamination. This is attributed to a damaged interlayer, caused during glass fracture.

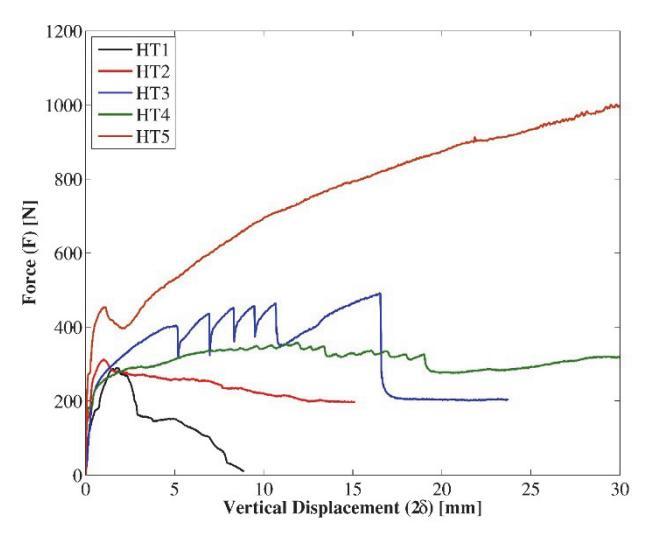
The force-displacement response of the specimens which were pre-conditioned with the high-temperature accelerated weathering procedure can be seen in figure 4. These specimens also show an initial linear response, with a peak force of 340 N. Beyond the linear phase, each specimen responded differently. As previously reported by Ferretti [14], TCT test responses are frequently very varied, even for newly-manufactured specimens.

Figure 4 Force displacement response for specimens subject to high-temperatures.

The high temperature specimens showed a stiffer response than newly-manufactured, forces were higher and delaminated lengths smaller. Ink from the dotted grid transferred from PVB to

glass, making digital image correlation difficult. Failure occurred by local tearing in specimens 1 and 2; slip at the glass- jaw interface in specimen 3; delamination in specimen 4; and global tension in specimen 5. The failure mechanisms were not significantly different to newly manufactured.

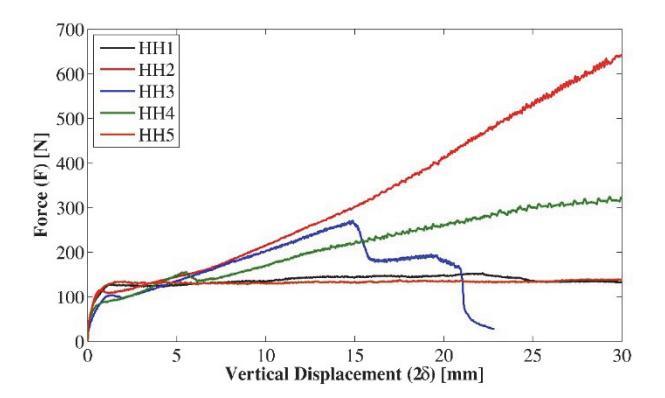
The force-displacement response of the specimens which were pre-condition with the high-temperature accelerated weathering procedure can be seen in figure 5. The response is markedly different to both the asnew and high-temperature categories. After the initial stretching phase, the steady-state delamination phase occurred at approximately 115 N. The delamination phase continued for significantly longer than the as-new and high-temperature specimens: specimens 1 and 5 remained in the steady-state delamination phase throughout the entire test duration.

Figure 5 Force displacement response for specimens subject to high-humidity.

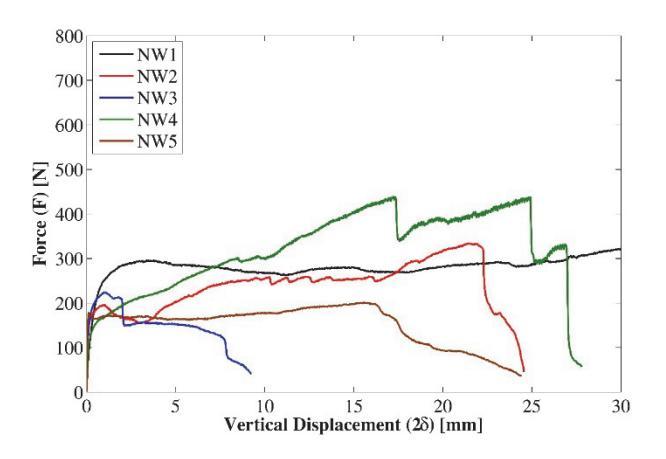
The naturally weathered specimens exhibited a lower load-carrying capacity than the as-new specimens. Steady state delamination occurred at just under 200 N, compared to 115 N in the high-humidity tests, and 275 N in the as-new specimens. The response can be seen in figure 6. Specimens 2-5 showed some uneven delamination and then tore. In previous categories, tearing was only seen when no delamination occurred, and it was attributed to interlayer damage. Specimens 2-5 all tore after delamination, suggesting a significant reduction in interlayer tear resistance.

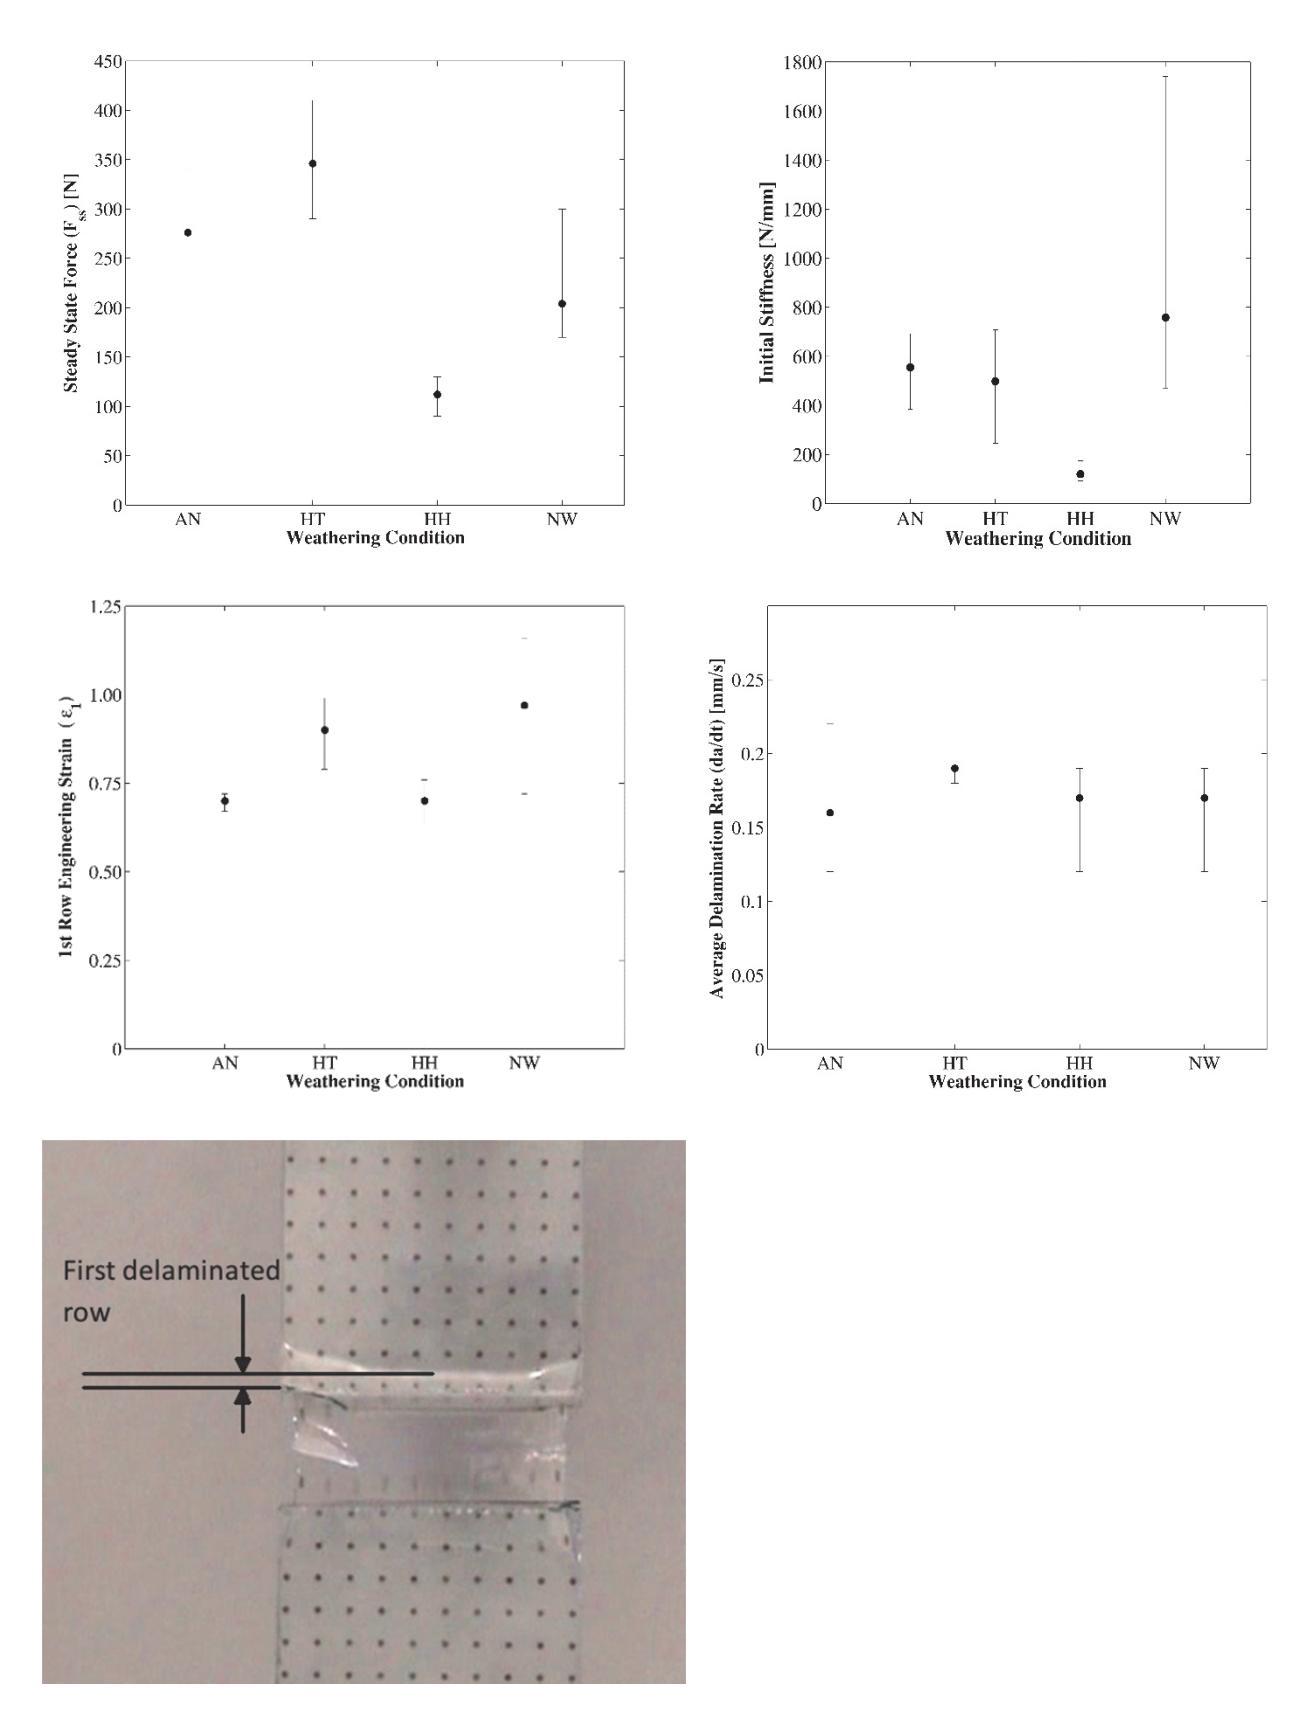
Figure 7 shows a summary of the test data for each weathering category. In image (*a*) the average steady state force as recorded during phase 2 of the test is shown. It is clear that the high humidity environment reduces the force required to delaminate the PVB interlayer. This is consistent with previously published results [1]. In figure 7(b) the average initial stiffness of each weathering category is shown. The stiffness is calculated for the linear phase (phase 1 in figure 3) only. This stiffness is recorded before significant delamination and is therefore a measure of the effect of weathering on the bulk interlayer shear modulus. Again, the humid environment was found to be severely detrimental to performance.

Figure 7 (a to e) Summary of test data for all weathering conditions, average and data range *a*) Steady state force, *b*) Initial stiffness, *c*) Decohesion strain, *d*) Delamination rate before onset of tearing, *e*) Material length considered for calculation of decohesion strain

In figure 7(c) the interlayer strain causing delamination is shown. This was calculated using digital image correlation software to measure strain in the first delaminated row (see figure 7(e)), This represents interlayer strain before significant creep and can be used to assess adhesive strength after weathering. Figure 7(d) shows the delamination rate before onset of tearing. A consistent response is seen across all categories. This is a strong indicator that adhesion is strain-governed as opposed to stress-governed. Finally, DIC was used to determine the interlayer strain profile at failure. The results can be seen in figure 8. In Figure 8 the strain profile represents a snap shot in time at the point of TCT specimen failure. The distance x represents distance, measured vertically from the specimen midline. The findings of all tests are summarised in table 2.

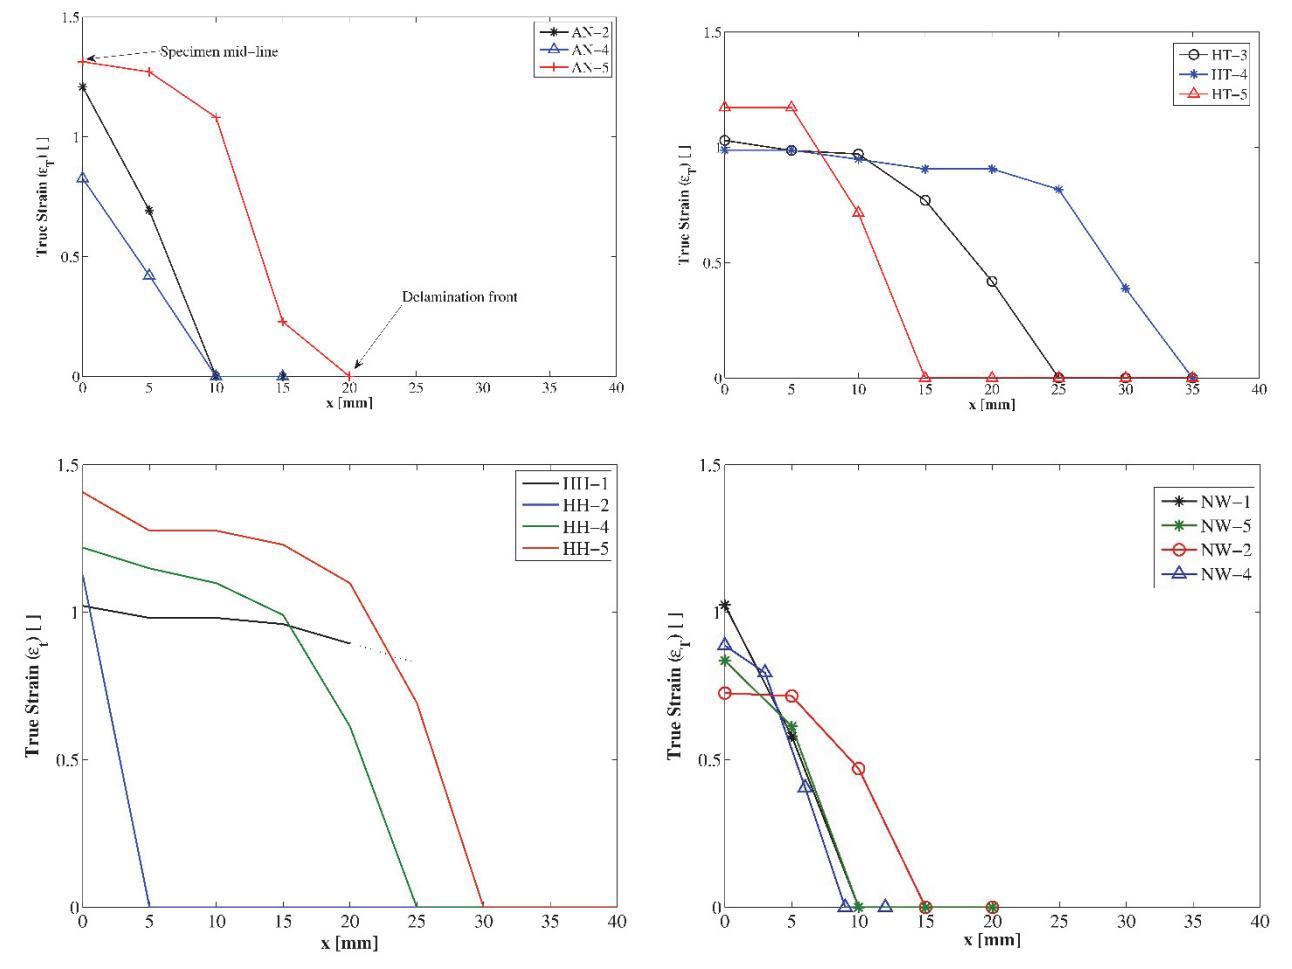
Figure 8 (a to d) Interlayer strain at Specimen failure, all weathering conditions, *a*) Newly manufactured specimens, *b*) High temperature weathering, *c*) High humidity weathering, *d*) Naturally weathered specimens.

These findings are reflected in the strain profile at failure shown in figure 8. The area below the strain profile curve combined with the steady state force, indicate energy dissipated by interlayer strain. The intersection with the x-axis shows the total delamination at failure.

More energy was dissipated as strain for the specimens which underwent high-temperature weathering. Both the area under the curve and steady state force are higher than newly manufactured. The observed high adhesion strength limited energy dissipated by delamination. Conversely, the total delaminated length was also higher, this suggests some increase in resistance to tearing. The specimens exposed to high temperatures, also exhibited a more symmetrical and even delamination; this could also account for the increase in total delamination.

There is an increase in area under the curve for the high humidity tests, however this is matched with a reduction in steady state force and increased test duration. From the strain profile alone it is difficult to decompose the global behaviour into the constituent bulk and adhesive parts.

The strain profile of the naturally weathered specimens shows that little energy is dissipated in both global deformation and interlayer delamination. Instead the energy is dissipated in local large strain mechanisms which eventually lead to tearing.
